Femoral Fracture Caused by Removal of Femoral Intramedullary Nail Made of Stainless Steel

Abstract

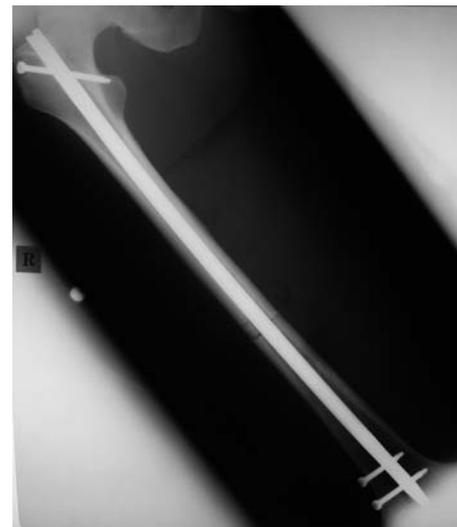
Figure 1. A postoperative AP radiograph showing anatomical reduction.

A 28-year-old man sustained a transverse fracture on his right femur while playing soccer. A week after the injury, intramedullary interlocking nailing was performed using a Zimmer (Warsaw, IN) ZMS[®] femoral nail. An intramedullary nail, 10 mm in diameter, was inserted after 11 mm reaming according to the standard reaming-nailing technique. The operation was completed without any trouble, and the postoperative radiograph showed favorable reduction (Fig. 1). Postoperative course also was uneventful, and he did not visit the hospital over a period of more than 1.5 years after the bone union.

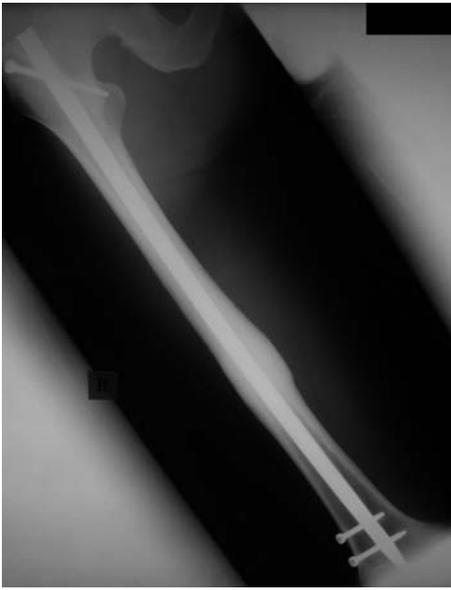
Figure 2. An AP radiograph taken immediately before the nail removal showing complete union of the fracture.

Two years and 5 months after the initial operation, the nail was removed at the patient's request. The radiograph immediately before the removal showed complete healing of the fracture with an anatomic alignment and without any hardware failure (Fig. 2). Following removal of interlocking screws, the intramedullary nail was tried to be extracted. The nail started to be pulled out with relatively little resistance at first, but considerably greater resistance was encountered after it was taken out several centimeters. After an addition of harder blows, the resistance suddenly disappeared and the nail was pulled out

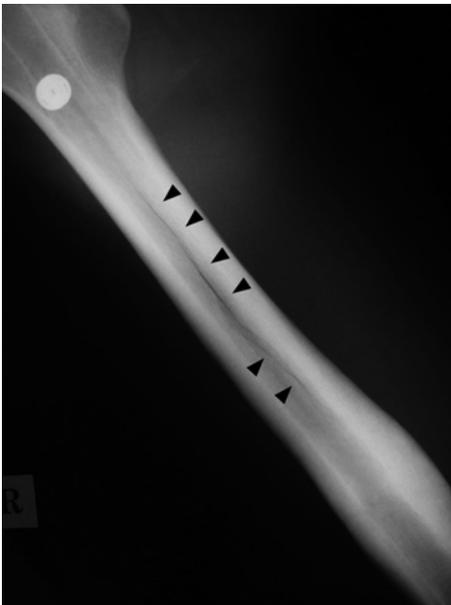
Figure 3. An AP radiograph taken immediately after the nail removal showing longitudinal fracture lines (arrows).

completely without stopping. There was no breakage in the removal instruments and the nail. However, the radiographs taken immediately after the removal demonstrated several new, longitudinal fracture lines proximal to the primary fracture site (Fig. 3). A CT image showed fracture lines that radiated in three directions (posterior, medial, and lateral) and a narrow, newly formed intramedullary bone that was the same in configuration as the nail surface (Fig. 4). The fracture was treated conservatively with protected weight-bearing. In the fifth postoperative month, the patient could tolerate full weight-bearing and no

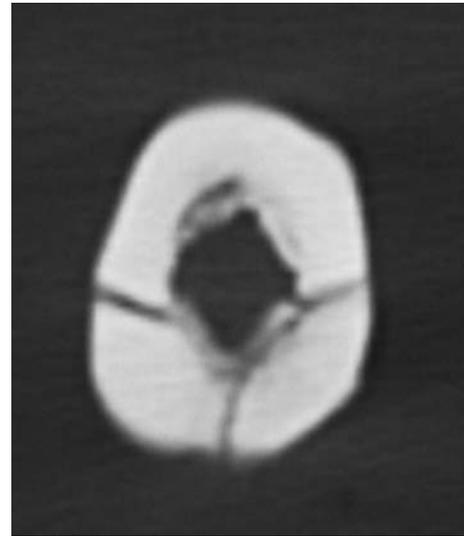
Figure 4. A CT image showing fracture lines that radiate in three directions (posterior, medial, and lateral) and a narrow, newly formed intramedullary bone that is the same in configuration as the nail surface.

In postoperative CT, the fracture lines were observed in three directions (posterior, medial, and lateral) of the femur. There existed a mature bone, which was newly formed in

the same configuration as the cross-sectional shape of the intramedullary nail. These findings suggest that the mechanism of the fracture is closely tied in with the structure of the nail stated above. That is, the mature, hard bone which was formed in the three flutes was hit against the distal cylindrical part of the nail at the distal end of the flutes when the nail was extracted, producing strong resistance, and eventually giving rise to a fracture. Seligson et al [5] reported two cases of irremovable interlocking femoral nails, including one case of 13 mm-diameter ZMS[®] femoral nail, and stated that the bone overgrowth into the slot of the nail might have prevented the distal, unslotted end of the nail from being extracted from the medullary canal. They recommended the use of nails with closed and constant cross-sectional designs to prevent the problem of difficult removal. Although the 10 mm-diameter ZMS[®] femoral nail used in our case did not have the slot and had a closed cross-section, it had flutes that stopped at the level above the distal holes for interlocking screws. Our case suggested the importance of the constant cross-sectional design to prevent the difficulties and the fracture on nail removal.

Although the nail used in our case was made of stainless steel, which is known as less osteoconductive material than titanium and its alloys, postoperative CT demonstrated abundant bone formation along the nail surface. This might be related to the micro-texture of the nail surface, in addition to the late removal and the patient age. The surface of the nail was not smooth because of the shot-peening applied for strength and corrosion resistance. It is known that, when the surface of a titanium implant is roughened, bone apposition onto the implant surface and bone-implant interfacial strength is increased [10]. This property seems not peculiar to titanium alloy [11], and it is possible that the roughened surface of the stainless steel nail accelerated osteoconduction on the nail surface. Unlike the surface of the metal implants for cementless arthroplasties, the surface of the metals for osteosynthesis would not have to be highly osteoconductive.

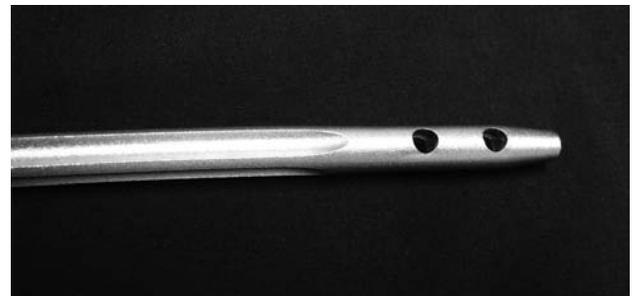
The Zimmer ZMS[®] femoral nail is made of stainless steel. The entire surface of the nail is treated with shot-peening to enhance the strength and corrosion resistance of the nail. It has flutes in the four directions to provide space for revascularization and to enhance fixation by four-point cortical contact. Nails which are larger in diameter (12 - 16 mm) have a slot anteriorly instead of a flute to increase the flexibility of the nail. The flutes stop at the level above the distal holes for interlocking screws to preserve the nail strength, and the cross-sectional shape of the distal end of the nail, several centimeters in length, differs from the upper part of the nail, being cylindrical except the thin anterior slot (Fig. 5).

Figure 5. ZMS[®] femoral nail (distal end).

When internal fixation is to be done with an intramedullary nail and its removal is to be expected, we consider it necessary to choose a nail whose cross-sectional shape does not differ at levels and whose surface is not rough. At removal, the structure of the nail as well as the period that extends to the nail removal should be considered.
